Name Of Dam: PEDLAR RIVER

## PHASE I INSPECTION REPORT NATIONAL DAM SAFETY PROGRAM

JUNE 1980

NAME OF DAM: PEDLAR RIVER DAM  
 LOCATION: AMHERST COUNTY, VIRGINIA  
 INVENTORY NUMBER: VA 00905

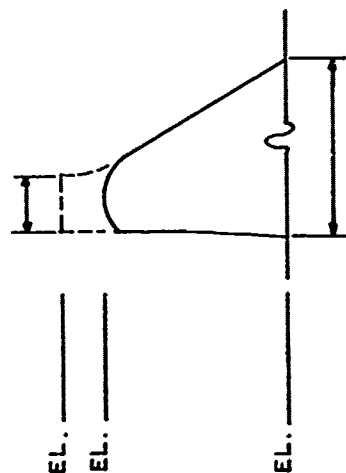
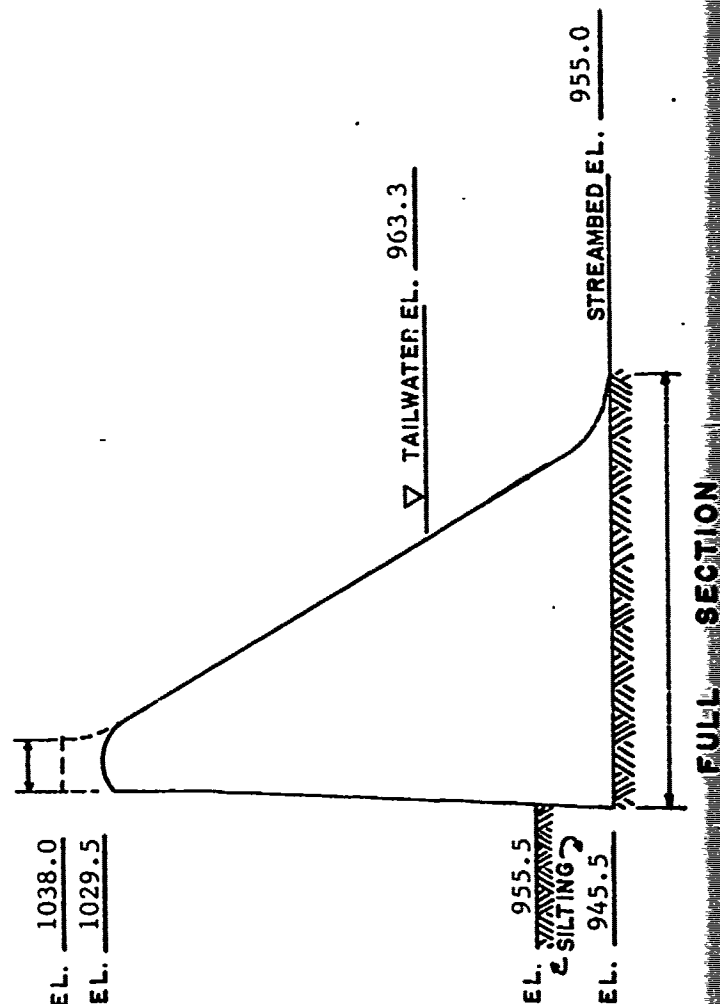
6.2.2 Stability Analysis: A stability check was made on a section of the spillway. The height of water behind the dam was assumed to be at the spillway crest, normal pool, and at 12.92 feet above the spillway crest, 1/2 PMF. For the normal pool condition, the vertical resultant of all forces fall within the middle third of the base. However, the overturning safety factor is only 1.54. For the 1/2 PMF condition the vertical resultant of all forces falls 7.75 feet outside of the middle third of the base and the overturning safety factor is 1.19. Under this condition the dam does not meet the stability criteria established in Reference 1, Appendix VI. Contract drawings show the dam base embedded in rock to such a degree that sliding is not a problem.

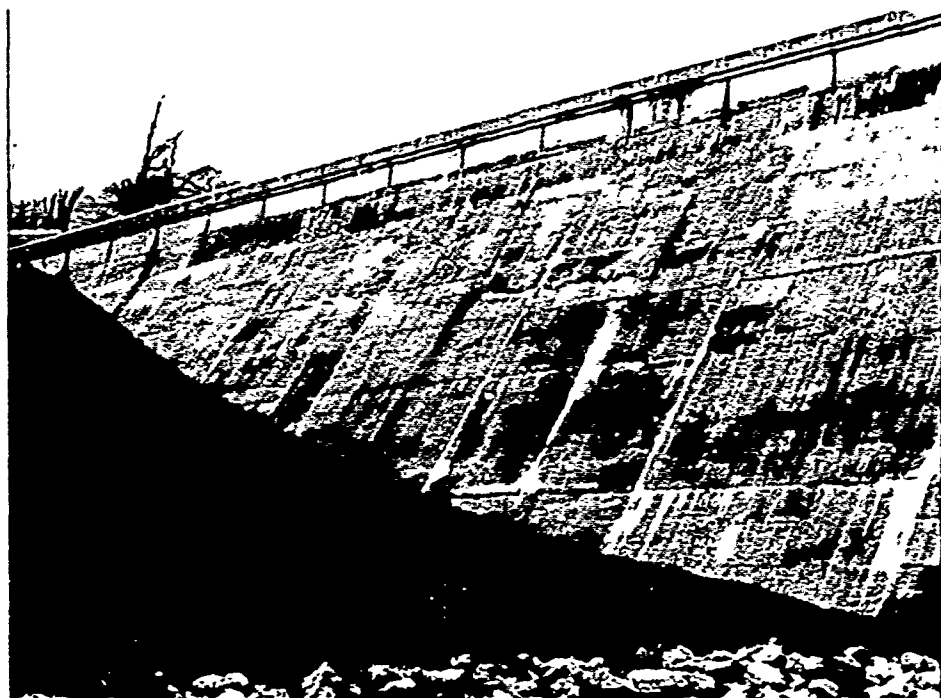
PHOTO # 3 DOWNSTREAM FACE

Of the six drains located on the face of the dam, four were discharging a small amount of water, less than 1 gpm. There was vegetation growing on the dam face below the one drain to the south of the spillway.

The drain discharges should be monitored periodically to note any change in flow or quality of discharge.

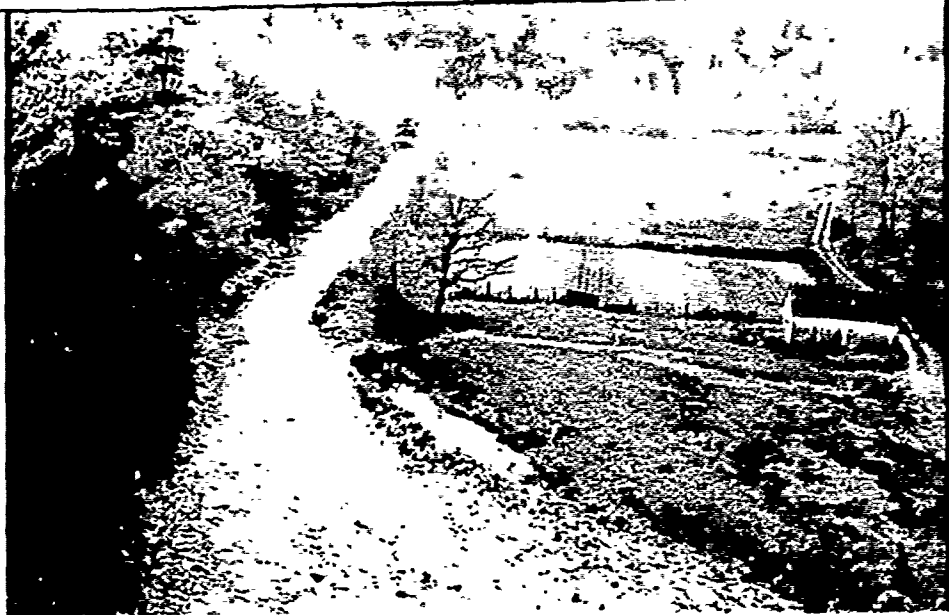
PHOTO #5 DOWNSTREAM AREA

3.2.3 Downstream Area: The downstream channel appeared stable. No signs of erosion were evident.
